RENEWABLE ENERGY FEASIBILITY STUDY FOR CITY OF TUCSON CLOSED LANDFILLS

for City Owned and/or Operated Landfills

TABLE 1 City Owned Closed Landfills March 2011

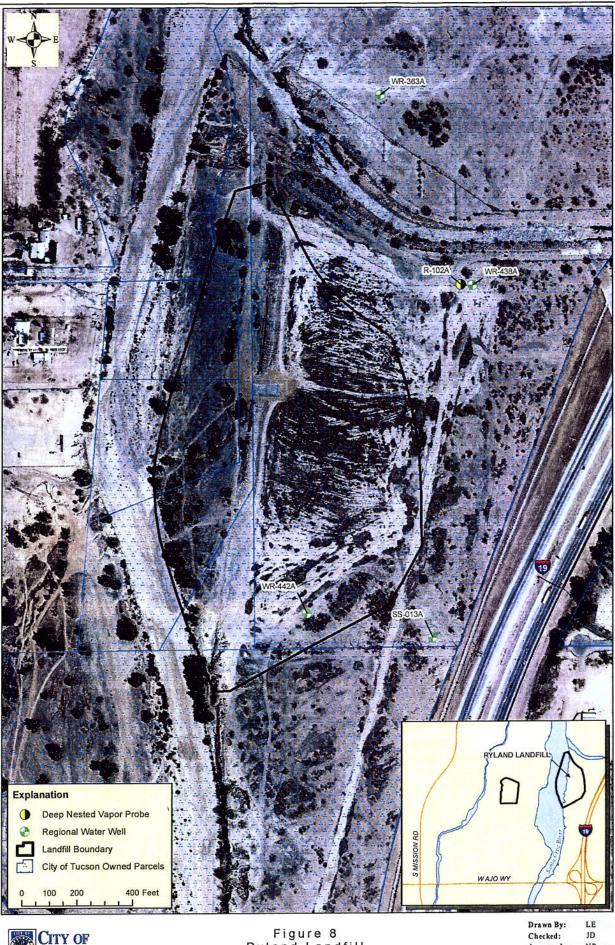
Figure 8 Ryland Landfill Inspection Site Map Drawn By: LE
Checked: JD
Approved: NP
Date: 10/22/2010
File: See Below
J G15/Envis on an eRCS/D40/Kyla radius A

46 KV power runs along the entire west border of the landfill. There is no flare station or power meter on the site. The landfill was closed in 1965 and is not a RCRA regulated site. The area is inspected and maintained by the City under a policy administered in 1996. There are no cap restrictions at the site and minimal cover over the waste. The landfill is not contaminated and is not registered under the state superfund program.

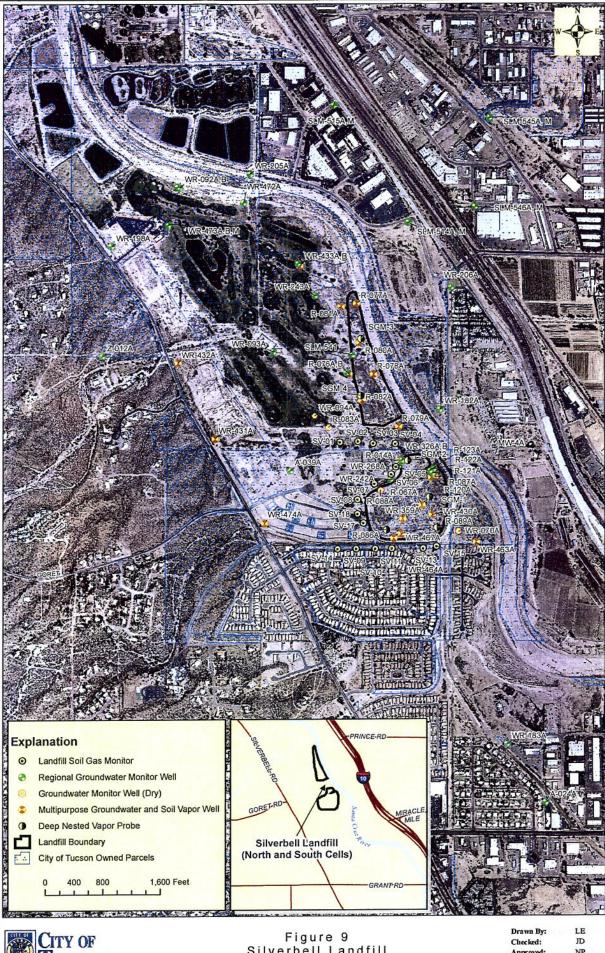
Figure 9 Silverbell Landfill Inspection Site Map

46 KV power runs along the southwest corner of the south cell. ES has a power drop and meter located between the north and south cells used to power remediation equipment. It is a 480 volt, 220 amp metered power source. There is no flare station on the site. The landfill was closed in 1975 and is not a RCRA regulated site. The area is inspected and maintained by the City under a policy administered in 1996. There are no cap restrictions at the site and minimal cover over the waste. The landfill is registered with ADEQ under the state superfund program, WQARF due to groundwater contamination below the site from buried waste. We have installed an SVE system to clean up the vadose zone and are currently designing a groundwater pump and treatment system for the site.
